CONFIDENTIAL SERVICE PHILCO

RADIO No. 26

DATE: 9-16-41

COMPLETE INFORMATION ON THE 1942 RECORD CHANGERS

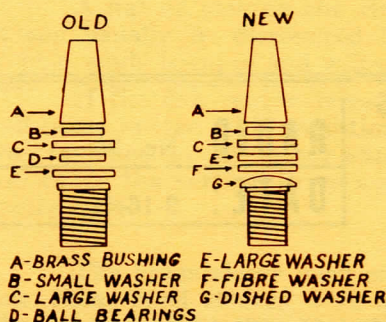
FIGURE 1

A. The rumble in the Models 42-1010 and 1016 can be easily corrected by replacing the turntable bearing. Remove the turntable and the spindle and then take out the brass cone and the ball bearings and washers. Rebuild the bearing, using the old washers and the new flat fiber washer and the concave steel washer. (See Figure 1). Add "Stay-Put Grease" or "Lubriplate" between the washers to eliminate friction. When replacing the spindle assembly, the spindle must be more than $\frac{1}{2}$ turn loose while lining it up with the record support shelf.

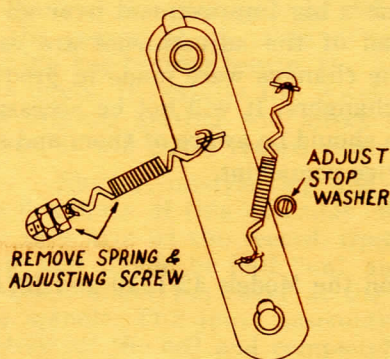
FIGURE 3

C. Flutter and change of speed is caused by friction in the vertical drive assembly and by the action of the regeneration spring (item 21 in Service Bulletin No. 402). The following changes involving the regeneration spring and the vertical drive assembly should be made on every changer on which there is an opportunity to do so.

Remove the regeneration spring and the threaded adjusting screw and nuts. (See Figure 3).

There is a small fiber washer which is used to limit the motion of the upper bearing support assembly. (See Figure 3). Loosen the screw holding this eccentric washer. Hold the vertical drive shaft at approximately 3° to the right of perpendicular and adjust the washer and fasten in place. (See Figure 6).
